Virginia Department of Forestry BMP Effort, Implementation, and Effectiveness Field Audit

•
November 2003

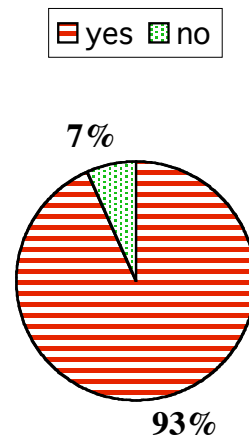
Efforts to implement BMPs were evident at 93% of inspected timber harvests, a decrease from the 100% recorded in June 2003, (*fig.1*). Quality of effort, rated on a scale of 1(poor) to 5(excellent), averaged 2.9, down from the 3.1 average of June 2003. Implementation of all necessary BMPs to

Fig. 1: Has An Effort Been Made To Apply BMPs, Regardless Of Meeting Technical Specifications?

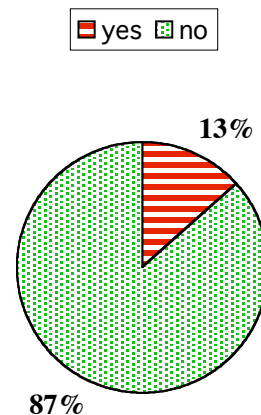
DOF standards occurred at 13% of inspected sites, (*fig. 2*).

Fig. 2: Were All BMPs Applied To Technical Specifications As Expressed In The BMP Manual?

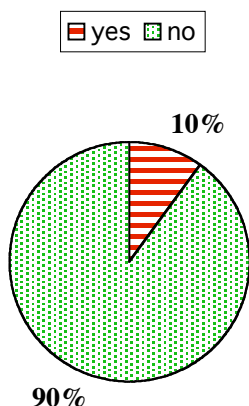
Active sedimentation existed at 10% of the inspected sites; equal to the 10% recorded in June 2003, (*fig. 3*). The potential for sedimentation was noted at 23% of the inspected sites, up from the 10% noted in June 2003, (*fig. 4*).

Fig. 3: Does Active Sedimentation Exist Now Because BMP Technical Specifications Were Not Met?

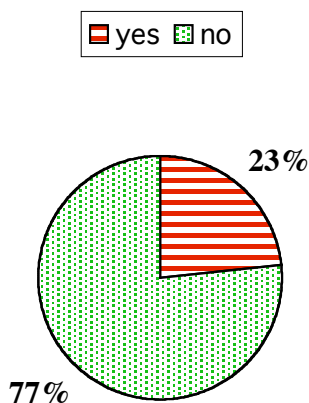
Fig. 4: Does The Potential Exist For Active Sedimentation To Develop Because BMP Technical Specifications Were Not Met?
